HOME INSPECTION REPORT

Friday, August 31, 2018

CTI Home Inspection LLC
886 Schuetter Rd
Jasper, IN 47546
812-639-3310
Curtyler@live.com

2241

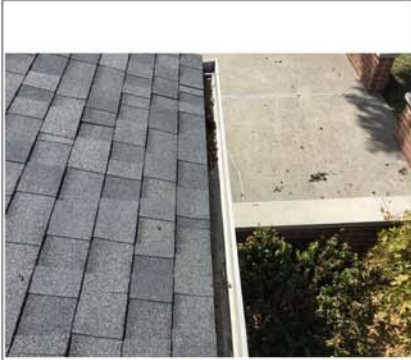
GUTTERS SOME LEAVES

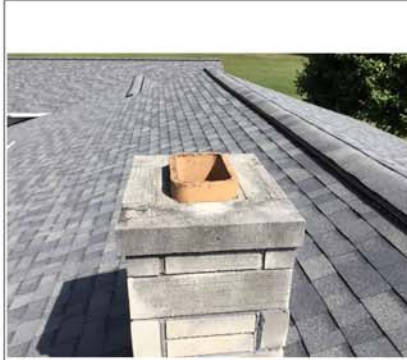
ROOF
Chimney rain cap missing.

RAIN CAP MISSING

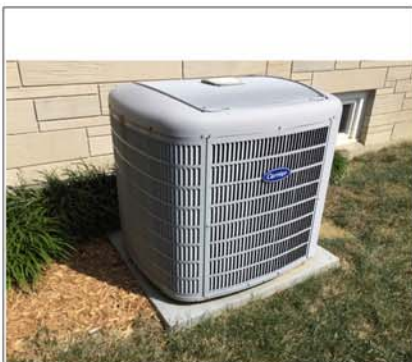
FINS DIRTY

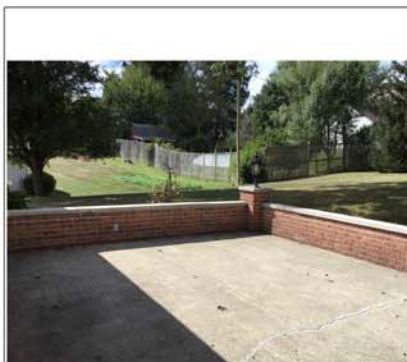
GROUNDS
Patio lights & 1 outlet trips breaker.

PATIO LIGHTS & 1 OUTLET
TRIPS BREAKER

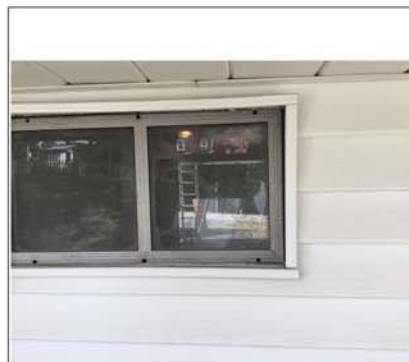
SHED WINDOW CRACKED

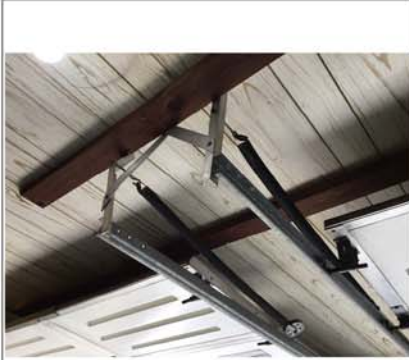
Both overhead doors safety cables missing & pressure reverse needs adjusted & no photo eyes.
Openers maybe to old for photo eyes only.

BOTH DOORS SAFETY
CABLES MISSING

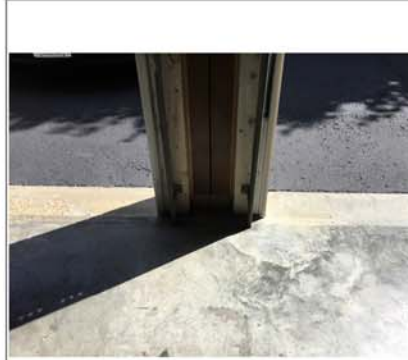
BOTH DOORS PHOTO EYES
MISSING BUT OPENERS
POSSIBLY TO OLD / BOTH
NEED PRESSURE REVERSE
ADJUSTED

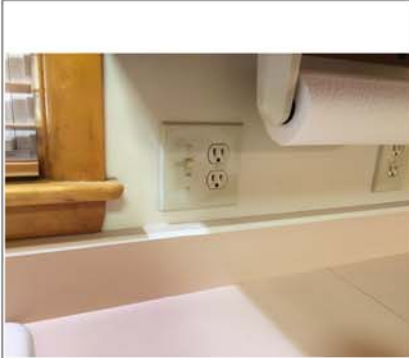
KITCHEN
Outlets at sink not GFCI.

Outlets at sink not GFCI.
 1 outlet east wall dining room-south between closet doors-hallway are open/ground.

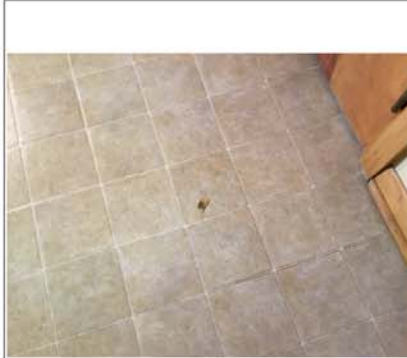
Floor spot

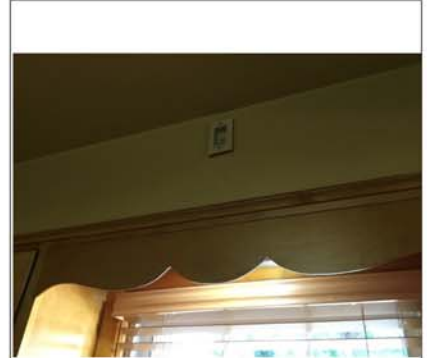
Outlet above sink loose in wall
 Light cover missing above sink

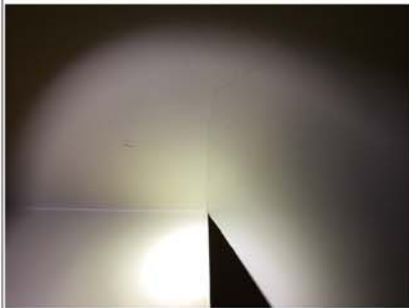
Ceiling typical crack at hallway

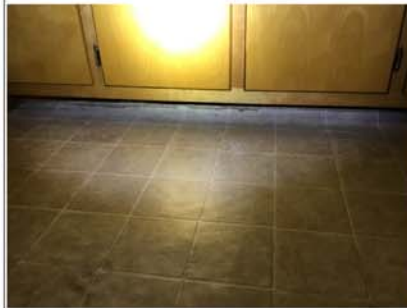
Flooring rolled up under sink cabinet
 Floor transition strip at door missing

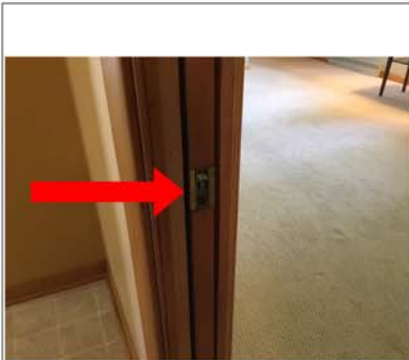
West pocket door did not open
Mechanism to open broke

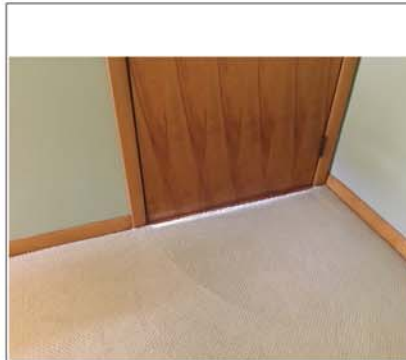
LIVING ROOM
Front door gasket missing - drags carpet - can see light at bottom when closed.
West pocket door mechanism to open broke - not opened.

Front door gasket missing
Drags carpet
Light shows under door when
closed

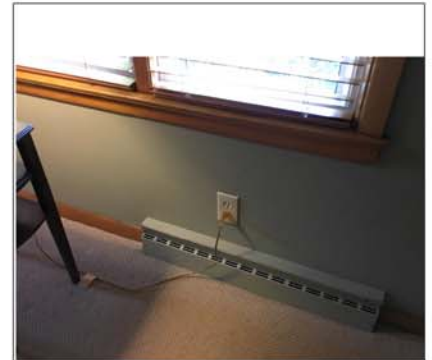
All outlets open/ground
Bottom half southwest outlet
works with switch

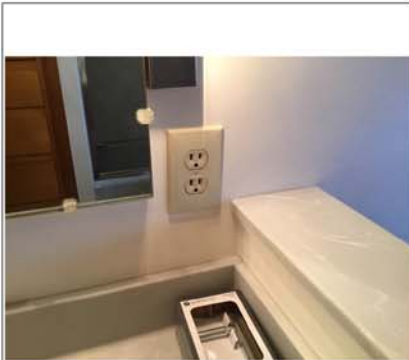
Outlets at sink not GFCI

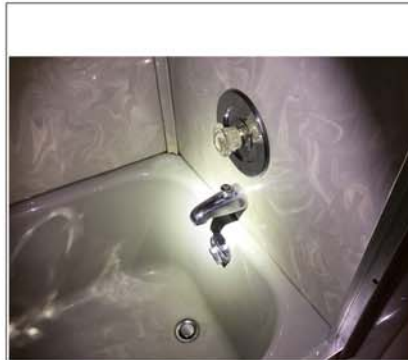
MAIN BATH
Outlet at sink not GFCI.
Tub diverter needs adjusted. Water comes out of spout-shower head at same time.

Tub diverter needs adjusted.
Water comes out spot-shower at same time

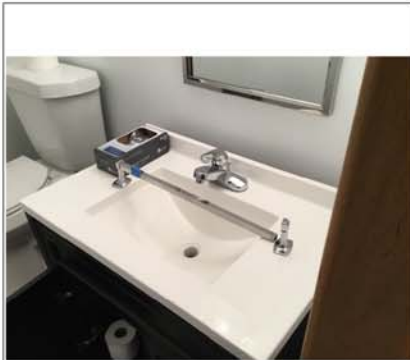
BASEMENT BATH
Sink not mounted-hooked up.
No outlet.

Sink not mounted-hooked up
No outlet

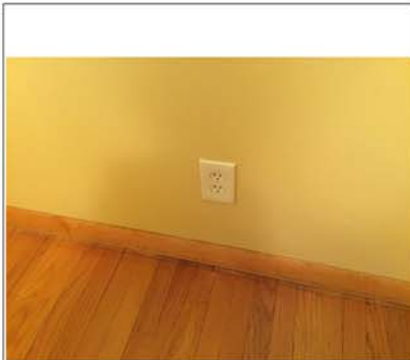
All outlets open/ground

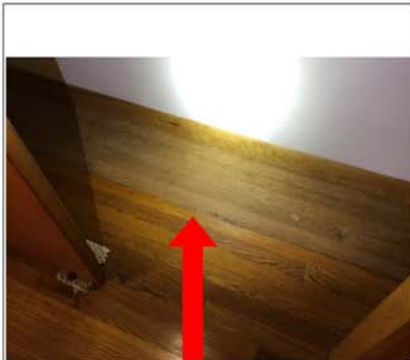
Closet floor some not stained

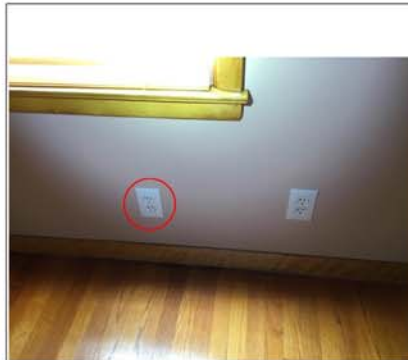
All outlets open/ground except 1 west circled

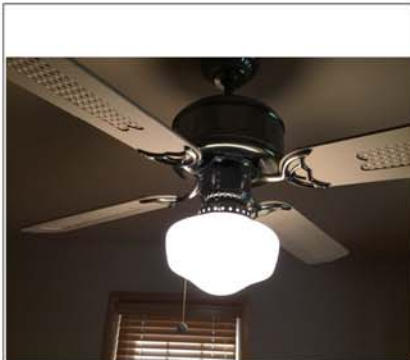
NORTHWEST BEDROOM
Fan wobble.

Fan wobble
Light pull chain missing

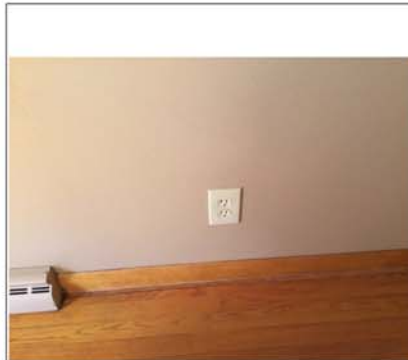
All outlets open/ground

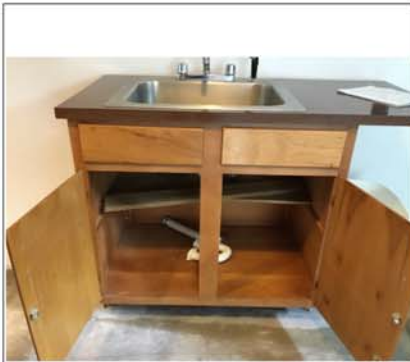
BASEMENT FAMILY ROOM
Sink not mounted-hooked up.

Sink not mounted-hooked up

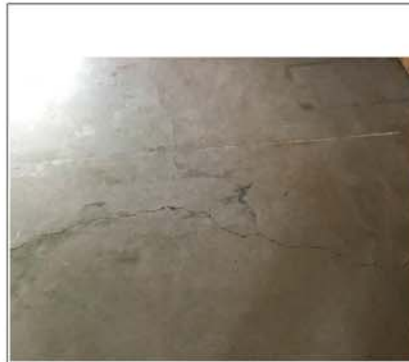
Floor typical cracks

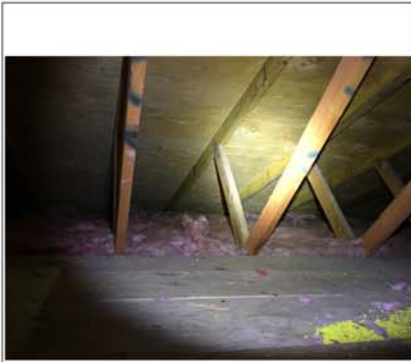
NO BAFFLES AT EAVE VENTS
IN GARAGE
No baffles in house

ATTIC HOUSE - GARAGE
Recommend baffles at eaves for better ventilation.

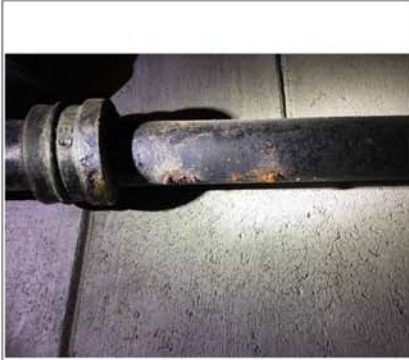
DRAIN PIPE SOME
CORROSION SPOTS

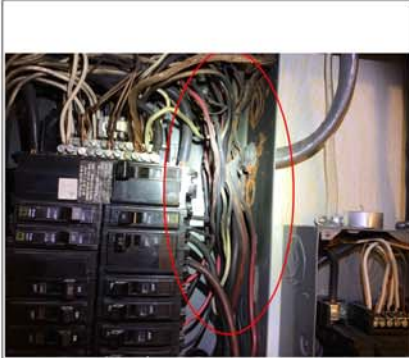
ELECTRIC PANEL
Multiple wires melted / burnt inside.
Cover difficult to remove. Cover not reinstalled.

MULTIPLE WIRES MELTED /
 COVER VERY DIFFICULT TO
 REMOVE / DID NOT REINSTALL
 COVER (cover on floor 2 screws
 on sub panel)

ELECTRIC PANEL.
100 AMP.
RECOMMEND
ELECTRICIAN
CHECK

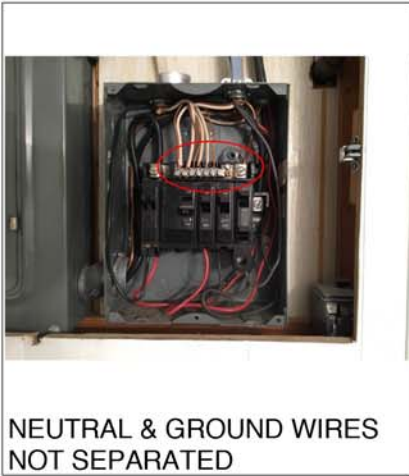
SUB PANEL
Neutral & ground wires not separated.

NEUTRAL & GROUND WIRES
NOT SEPARATED
